Manhole Inspection Summary

Manhole # S37YY_001MH

Location Address: **616 HOMESTEAD ST**

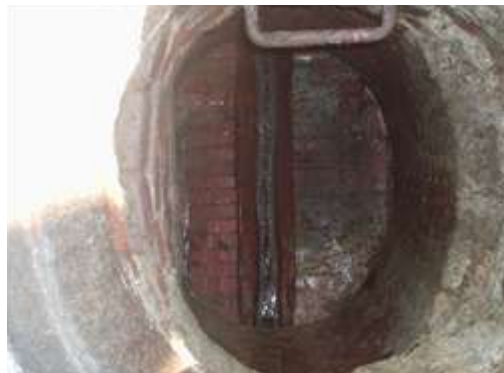
Top View

Frame leaks. Corroded steps. Bench debris.

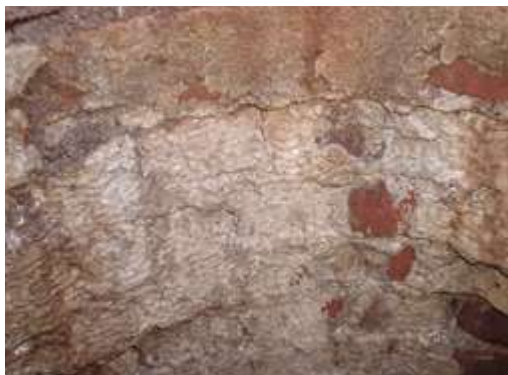
Defect

Condition: ☐ Sound ☐ Cracked ☐ Root Intrusion ☐ Loose Brick ☒ **Deteriorated**

Infiltration: ☐ None ☒ **Joint** ☐ Cracks ☐ Mortar ☐ Roots ☒ **Wall**

Adjustment deterioration and infiltration.

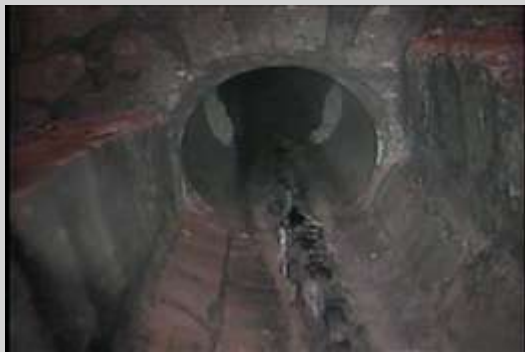
8 in. Circular Gravity Sewer Pipe Out @ 12 O'Clock

Infiltration: **Evidence** Pipe Seal Cond: **Unknown**
